NIOSH
Fire Fighter Fatality Investigation
and Prevention Program

Motor-Vehicle Incident Claims Life of Volunteer Fire Fighter Who Was Responding to Alarm - Ohio

Fatality Assessment and Control Evaluation Investigative Report #99F-44

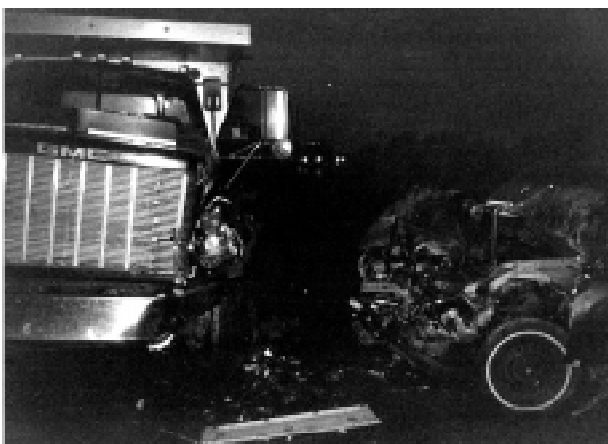
Vehicles Involved in Incident

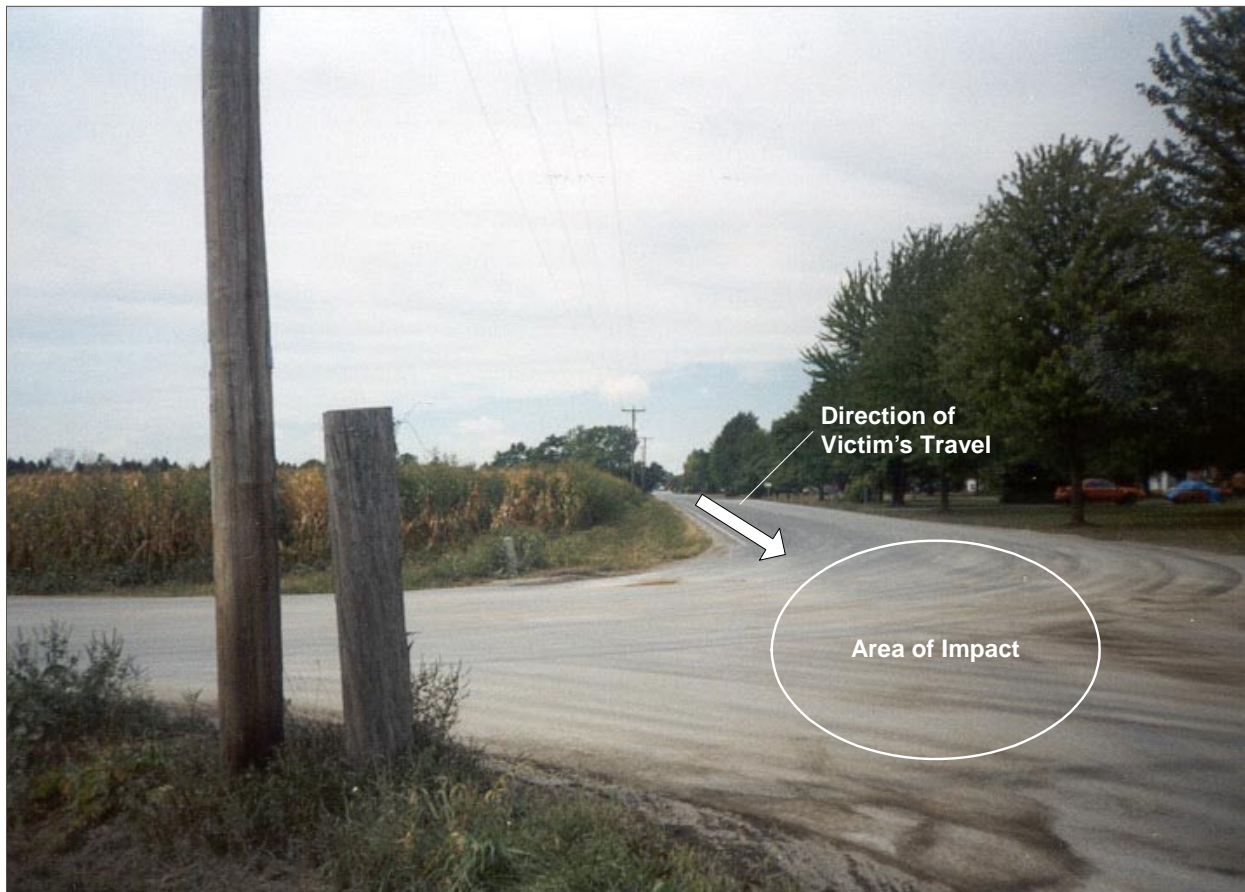
Figure 1. Incident Site: Intersection

planted in the area bordering this intersection. The corn was approximately 6 feet in height (see Figure 1). The driver of the dump truck stated that when he was stopped at the stop sign, he saw the victim's vehicle with its headlights turned on approximately 450 feet away. As he proceeded into the intersection, he stopped the dump truck when he noticed the victim quickly approaching. The victim collided with the front axle of the dump truck. Note: The driver of the dump truck recalled seeing the victim's red light only when the victim was in close proximity. It is believed that the victim activated his light and siren when he saw the dump truck at the intersection. At 0659 hours, the driver of Engine 81, en route to the fire, noticed a large dump truck stopped in the middle of an intersection approximately 1/4 mile in front of him. Approaching the intersection, he advised Central Dispatch of a motor vehicle incident involving a large dump truck and a full-size automobile. The vehicle involved in the incident was that of a fellow fire fighter (the victim). He requested a mutual aid department be sent to the fire while he responded to the motor vehicle incident. At approximately 0704 hours, a fire fighter (Fire Fighter #1) en route to the original call of a kitchen fire, arrived by POV at the motor-vehicle incident site. At this time the driver of Engine 81 notified Central Dispatch to ask the local EMS and a back up department to respond to the motor-vehicle incident. Fire Fighter #1 was instructed by the driver of Engine 81 to go to the station approximately 1/2 mile away to get the Brush Truck which contained the jaws-of-life. The driver of Engine 81 approached the vehicle and found that the victim had no pulse and was unresponsive. At approximately 0707 hours, the local EMS and Fire Fighter #1 returning with the Brush Truck, arrived simultaneously at the incident site. The driver of Engine 81 and a member of the local EMS removed the jaws-of-life from the Brush Truck and began extrication. At approximately 0709 hours, two trucks from a neighboring fire

Intersections are the most likely place for an incident to occur. When approaching an intersection, the driver/operator should slow the emergency vehicle to a speed that allows a complete stop in the intersection if necessary. The emergency vehicle should be brought to a complete stop if obstructions, such as buildings or trucks, block the driver/operator's view of the intersection. The emergency vehicle should only proceed if the driver can account for all lanes and ascertains that it is safe to proceed. In this incident the victim's visibility was obstructed due to the time of day that the incident occurred (0655 hours), the weather (minimal fog with a slight dew on the road surface), and the decreased visibility of the intersection due to the crops (corn) planted in the fields bordering this intersection.

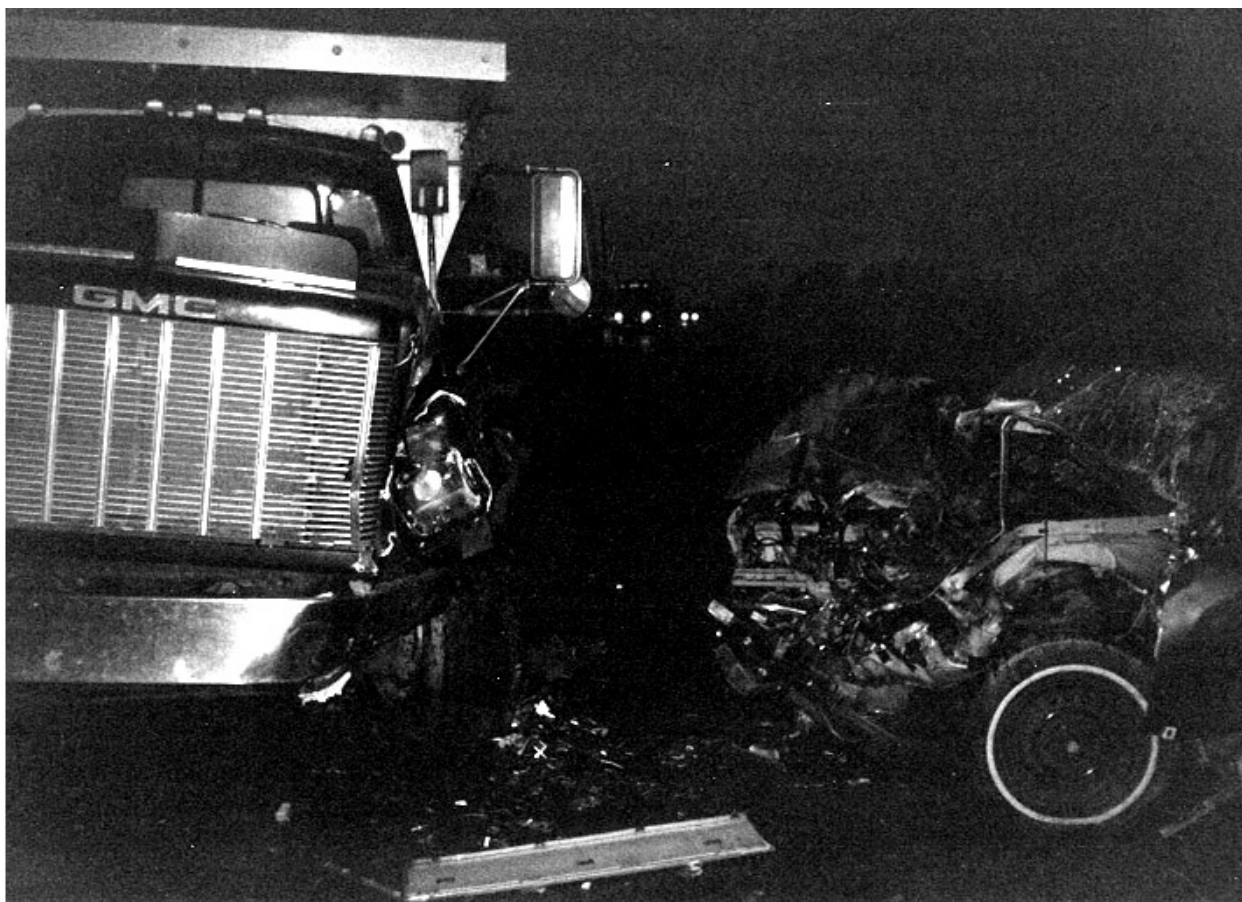
Figure 2. Vehicles Involved

The victim's POV was a 1989 Cadillac DeVille. His POV was equipped with a single-mounted red deck light, which met the requirements in the Ohio Revised Code Section 4511.45. At the time of the incident the victim was wearing his seat belt (lap and shoulder). The dump truck was a 1974 GMC Brigadier. It had three axles and a gross vehicle weight rating (GVWR) of 54,500 lbs. At the time of the incident, the truck was carrying 18 tons of stone, causing it to be over its weight limit by 3,800 lbs. The truck was not equipped with a seatbelt (lap or shoulder).

The victim was traveling eastbound on a two-lane state highway. A tandem dump truck was stopped at the stop sign of a road that intersected the one on which the victim was traveling. The driver of the dump truck started a left turn, heading westbound onto the road the victim was traveling. *Note: The intersection was partially obscured by a corn crop*

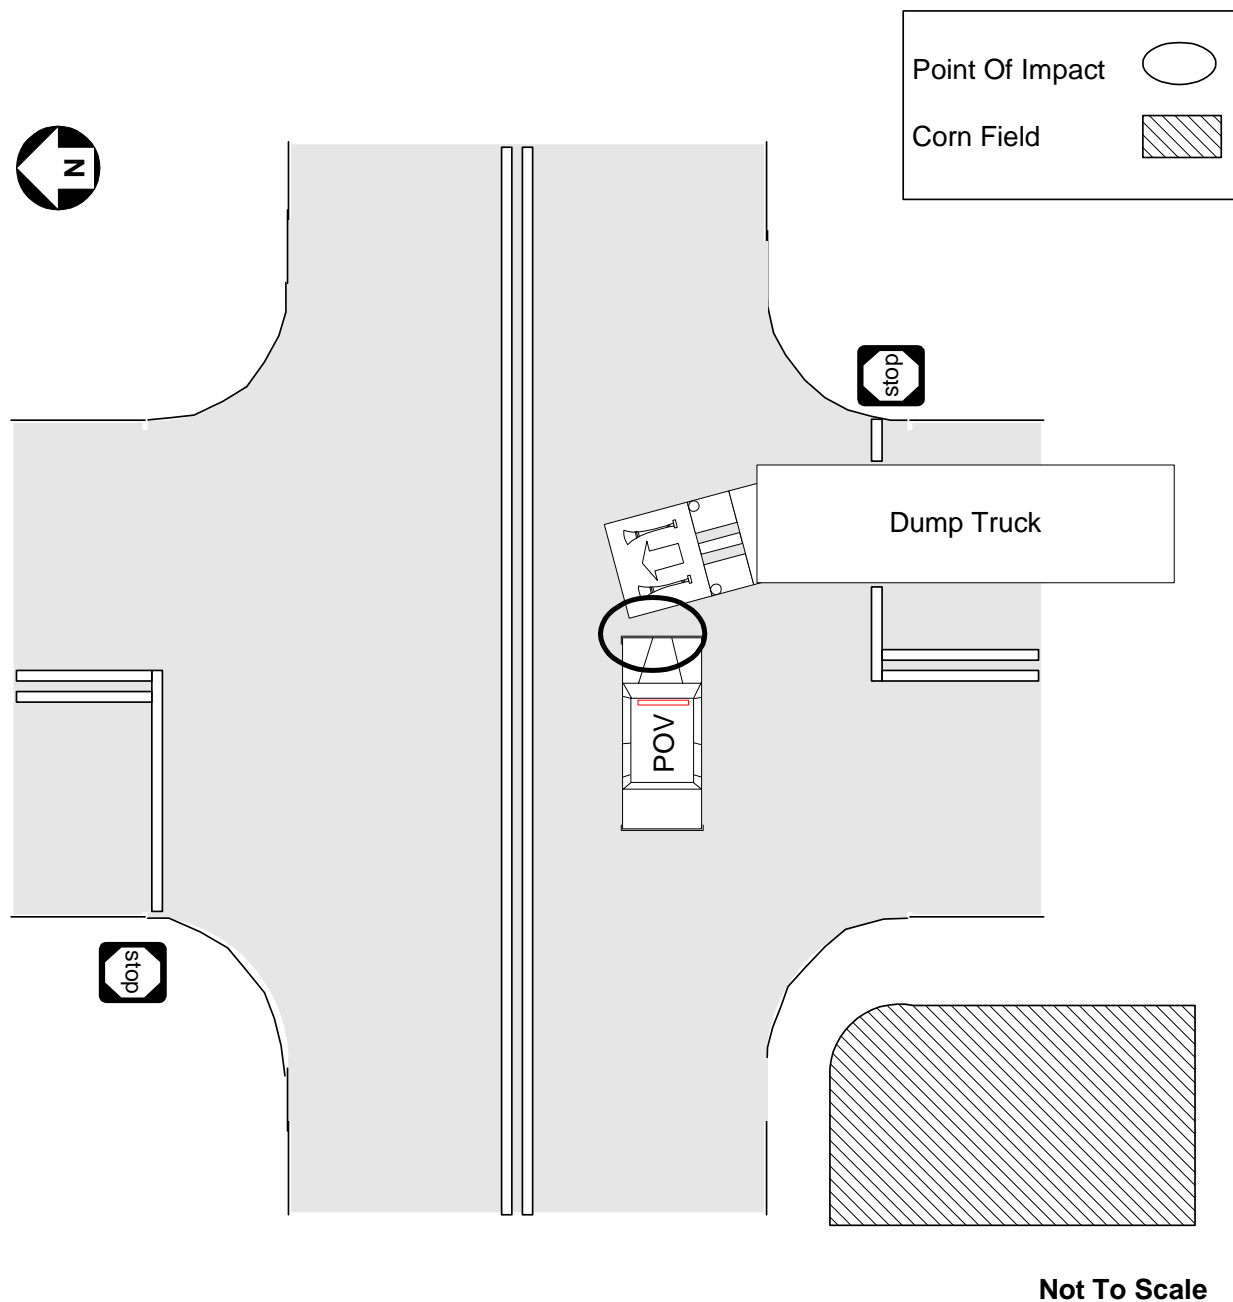
Figure 3. Aerial View

The incident occurred at the intersection of a state road approximately ½ mile from the fire station. The road was a standard two-lane asphalt road with a dashed center line in the eastbound lane (the direction of the victim's travel), a solid yellow line in the westbound lane and white fog lines separating the road edge from the shoulder. The posted speed limit is 55 mph. The intersection where the incident occurred was partially obscured by a corn field. The weather conditions at the time of the incident were as follows: a relative humidity of 97%, an ambient air temperature of 64° F, and a visibility of 4.0 miles. The road was wet from light rain at the time of the incident.
